PARTS FAMILIARIZATION WORKBOOK NO. I

Section 3: 140

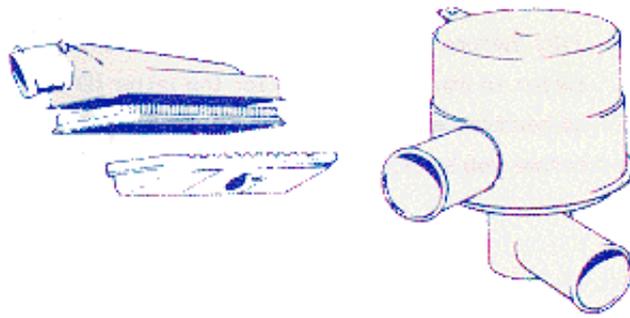
Many new and mysterious looking parts appeared with fuel injection. This new system contained many parts that didn't look like anything else. Fuel injection was one of the first examples of a new trend toward more complex parts. It's easy to get confused, so don't feel alone.

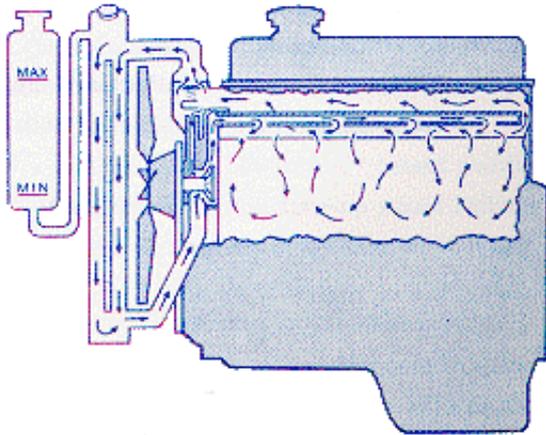
Whether the 140 was mild or wild, it had to keep cool. The cooling system was an improved version of previous designs. Key parts to know are the:

- Water pump -- made of aluminum, located in the front of the engine and driven by a

fan belt.

- Thermostat -- found on top front of the cylinder head and available by temperature range.
- Hoses - both upper and lower radiator hoses and heater hoses are molded to fit the curves of the engine compartment.

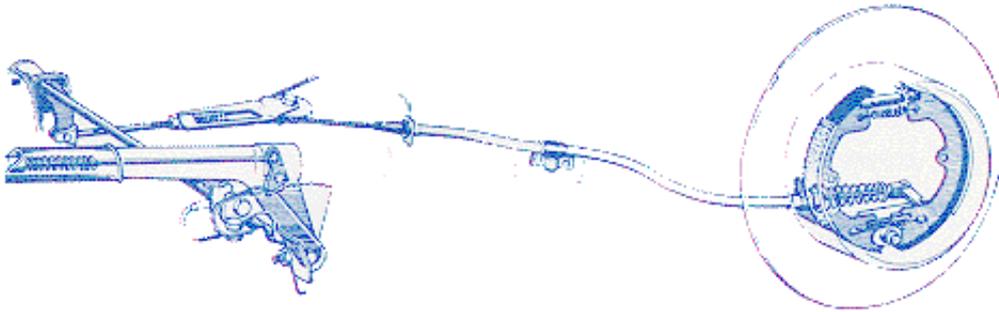
All 140s had solid, non-vented brake rotors (except the 1971 142E -- the front rotors were ventilated) on all four wheels. A small drum brake was designed into the left and right rear rotor hubs. A small set of brake shoes are contained inside the hub and act as the parking brake. Both sets of brake shoes in each hub are operated by one cable.

In time, the cable will stretch out of adjustment and need to be replaced. The brake shoes will also need replacement eventually.

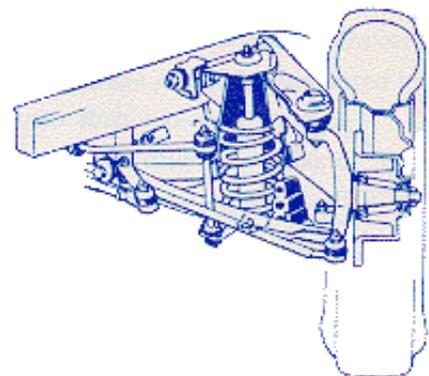
The 140 Volvos have an independent coil spring front suspension that uses upper and lower wishbones (also called "All arms, control arms) connected to a front crossmember. Upper and lower ball joints are pressed into each wishbone and connect the steering knuckles to the wishbones. A stabilizer bar (also called anti-roll bar, sway bar) is also included on the front end.

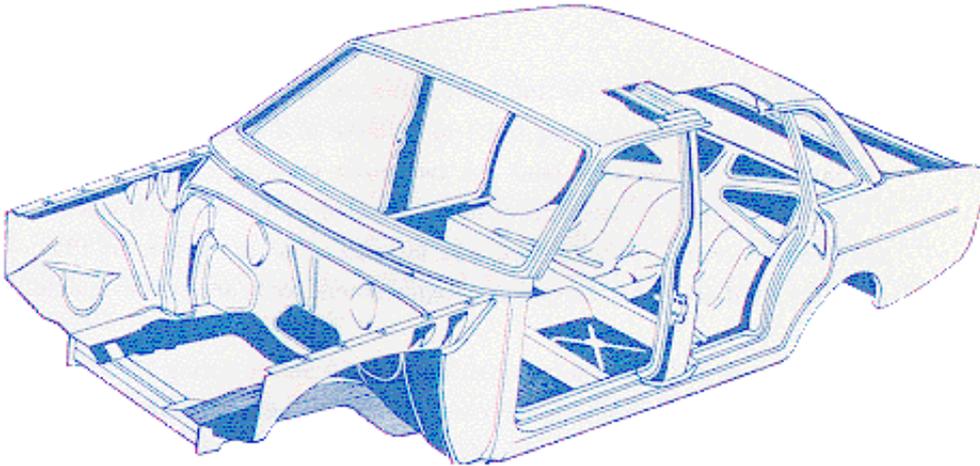
The 142, 144 and 145 model bodies are refinements of the unit-type construction of earlier Volvos. An average of 350 sheet metal component parts and 90 different subassemblies (groups of smaller parts) were used in a 140 body. Every body was manufactured from large panel section parts that were spot welded together. The finished 140 body contained the following features:

- Each spot weld (10,000 in all) that joins the panel sections is strong enough to support the weight of the entire body.
- The panel sections were welded to form a complete body. Then the doors, hood, trunk lid and other parts were fitted.
- Flat panel surfaces were reinforced with special Stampings for strength. These reinforced panels were combined to form a protective "safety cage" around the passengers.
